15-YR. OLD COLORADO TPO MEMBRANE SAVED WITH SILICONE RESTORATION

Project Profile

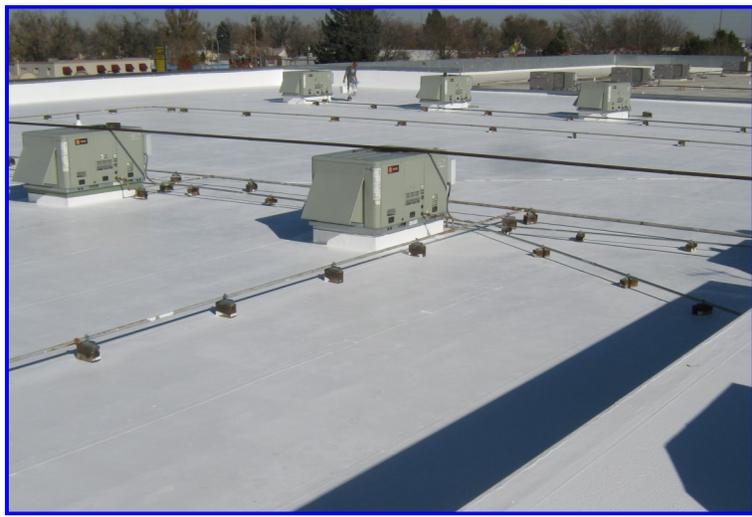
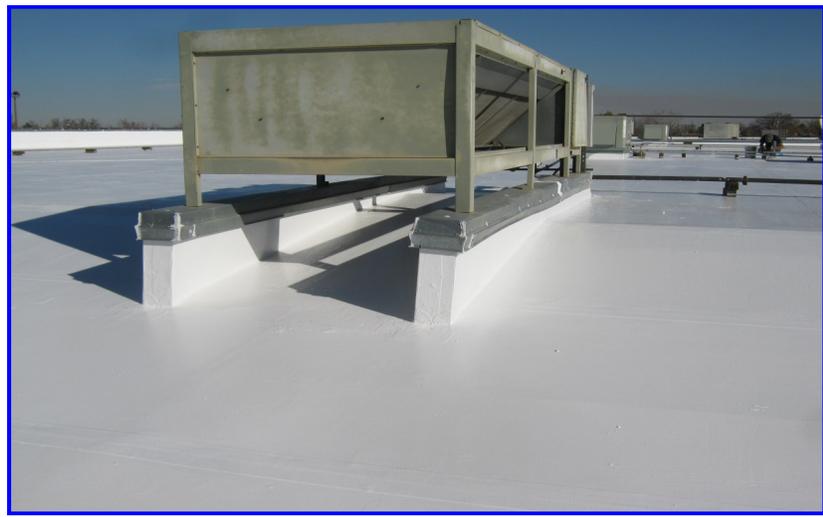
Supplied by the very first TPO manufacturer, this TPO membrane was 15+ years old and in bad shape. The building owners had done extensive repairs including applying EPDM tape on all the seams as seen in the “before” pictures. The sun had weathered and eroded the membrane down to the point that the internal reinforcing fabric was showing through in many places. Leaks were evident throughout the multi-tenant property and tenants were withholding rent payments until the roof was made watertight.

First an adhesion test was performed to determine if a silicone restoration would provide a viable solution. The test revealed that the silicone had great adhesion to the TPO but only marginal adhesion to the EPDM tape repairs. Therefore the decision was made to use a primer only on the EPDM taped areas, then apply the high solids, low-VOC silicone restoration system over the entire roof and parapet walls.

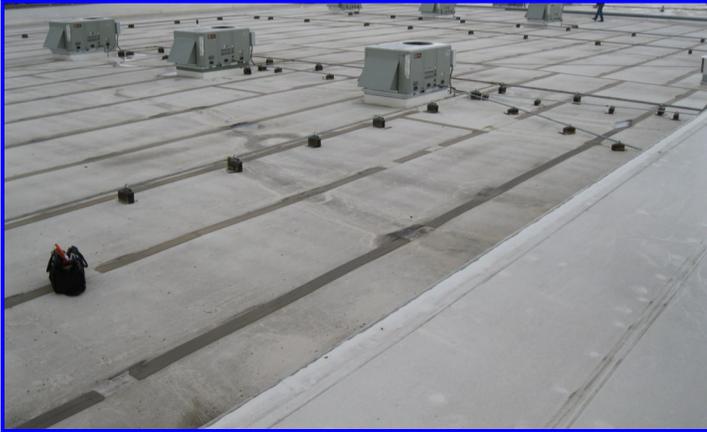
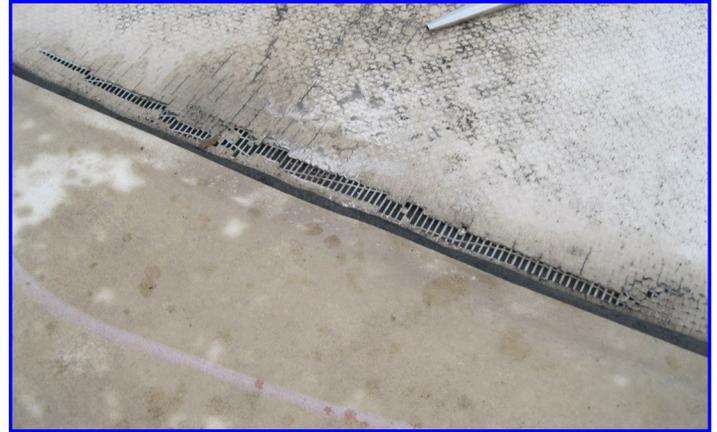
The TPO membrane had worn down to the point that the internal reinforcing fabric was exposed in areas.

- Performed an adhesion test on TPO membrane and EPDM repair materials.
- Pressure washed the roof to remove surface oxidation and dirt. Applied primer to EPDM repair material.
- Inspected roof and repaired cuts, punctures, all deficient roof/wall seams and roof penetration/edge flashings with a 3-course treatment of silicone + reinforcing fabric + silicone.
- Sealed 26,000 sq. ft. of roof and walls with a seamless, high solids, low-VOC silicone roof coating system.
